OPERATING EXPERIENCE SUMMARY

Office of Environment, Safety and Health

Summary 2001-09

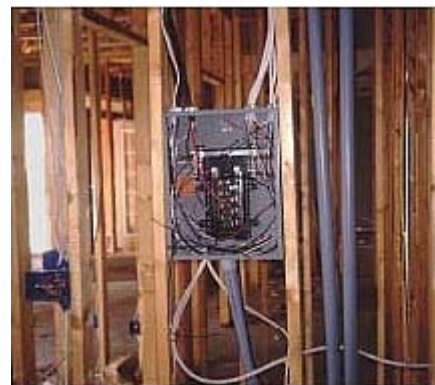
There have been a number of incidents in recent months in which energized electrical cables in conduits were penetrated or severed during construction, modification, or demolition activities at DOE facilities. No serious injuries resulted from these unanticipated intrusions on electrical lines, and they were categorized as near-misses. The frequency of these incidents has averaged approximately two per month for the past two years, and five events occurred in the 11-day period September 29 through October 9, 2001. A general characterization of the events is that the workers were either unaware that the energized cables were in the path of their work, or they were aware that a nearby conduit existed, but breached it inadvertently. Work plans for the activities resulting in these preventable events were either not followed or deficient. Figure 1 shows a typical assemblage of wires, cables, conduits, and piping being installed in a wall during construction, before concealment.

Figure 1. Wires, cables, conduits, and piping being installed in a wall
